# Decontamination and Decommissioning of the Organic Moderated Reactor Experiment Facility (OMRE)

Robert E. Hine

September 1980

**EG&G Idaho, Inc.  
Idaho Falls, Idaho 83415**

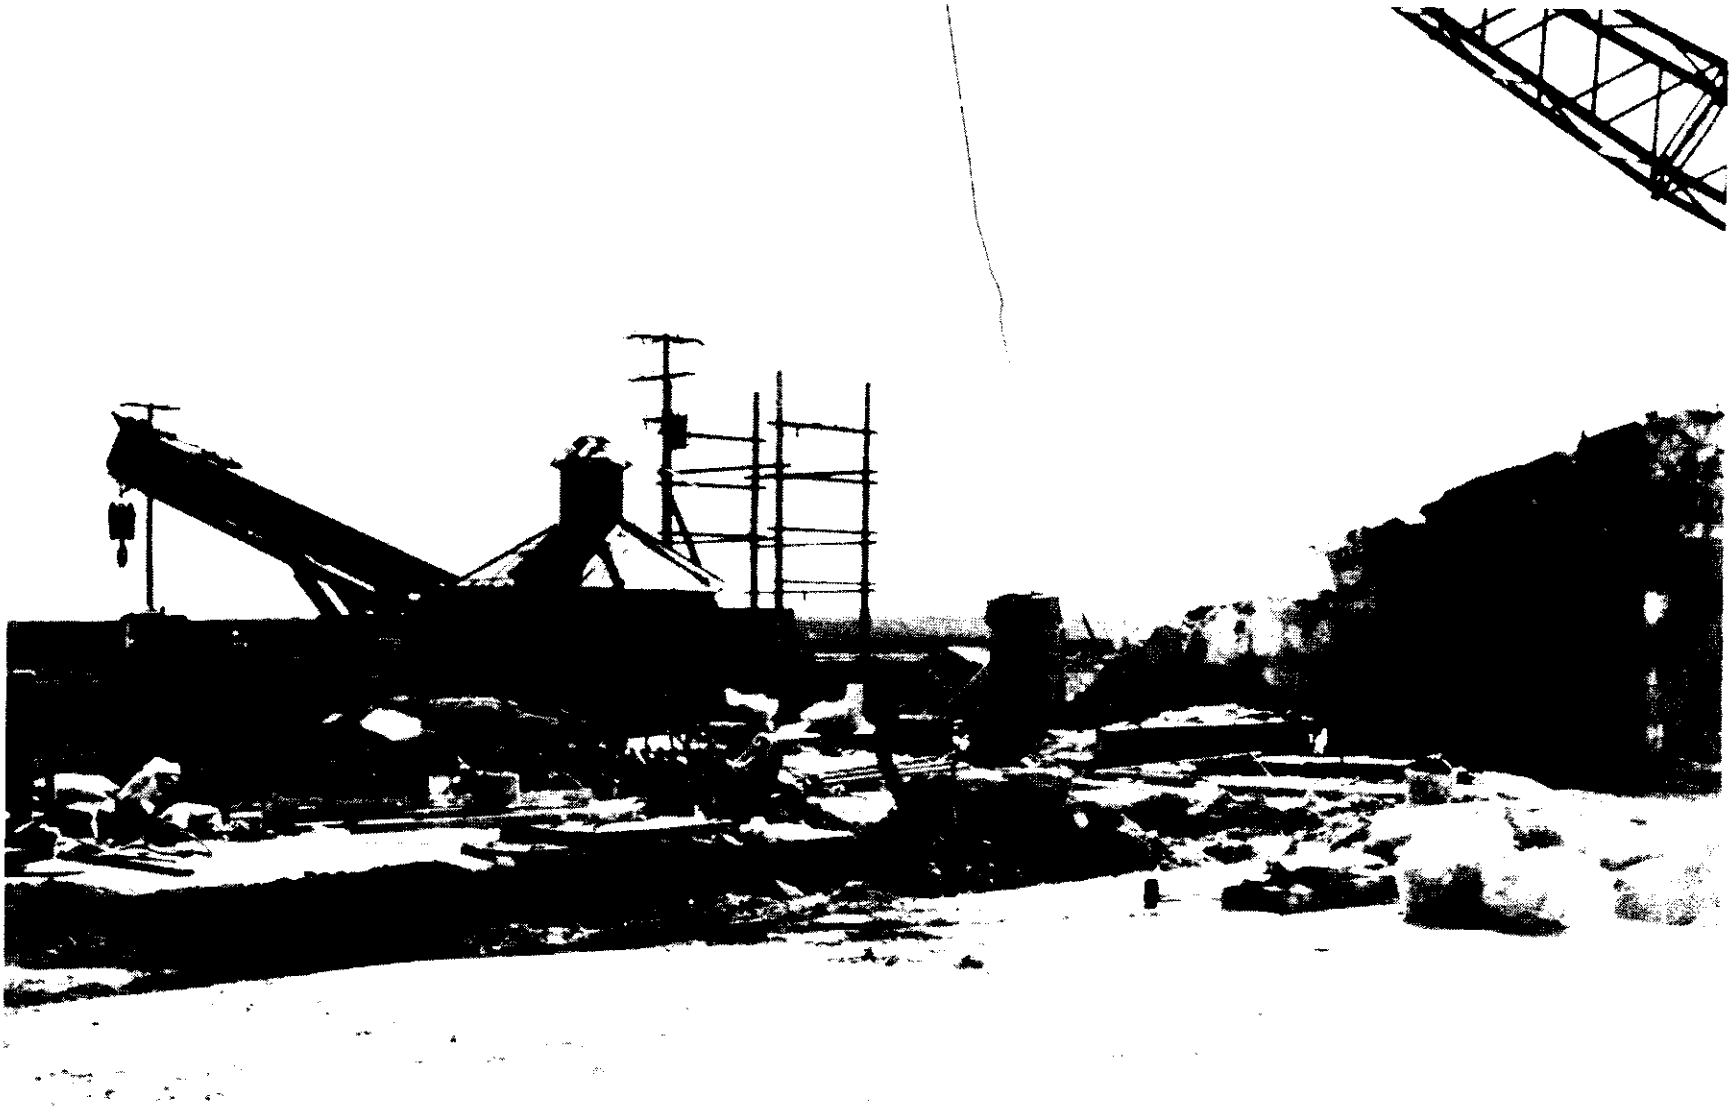
**Underground Tanks.** After the systems described above were removed, tank excavations and concrete demolition was started (see Figure 43). The following underground tanks existed in this facility:

Figure 43. OMRE site after piping and aboveground tanks have been removed. Concrete demolition in progress.

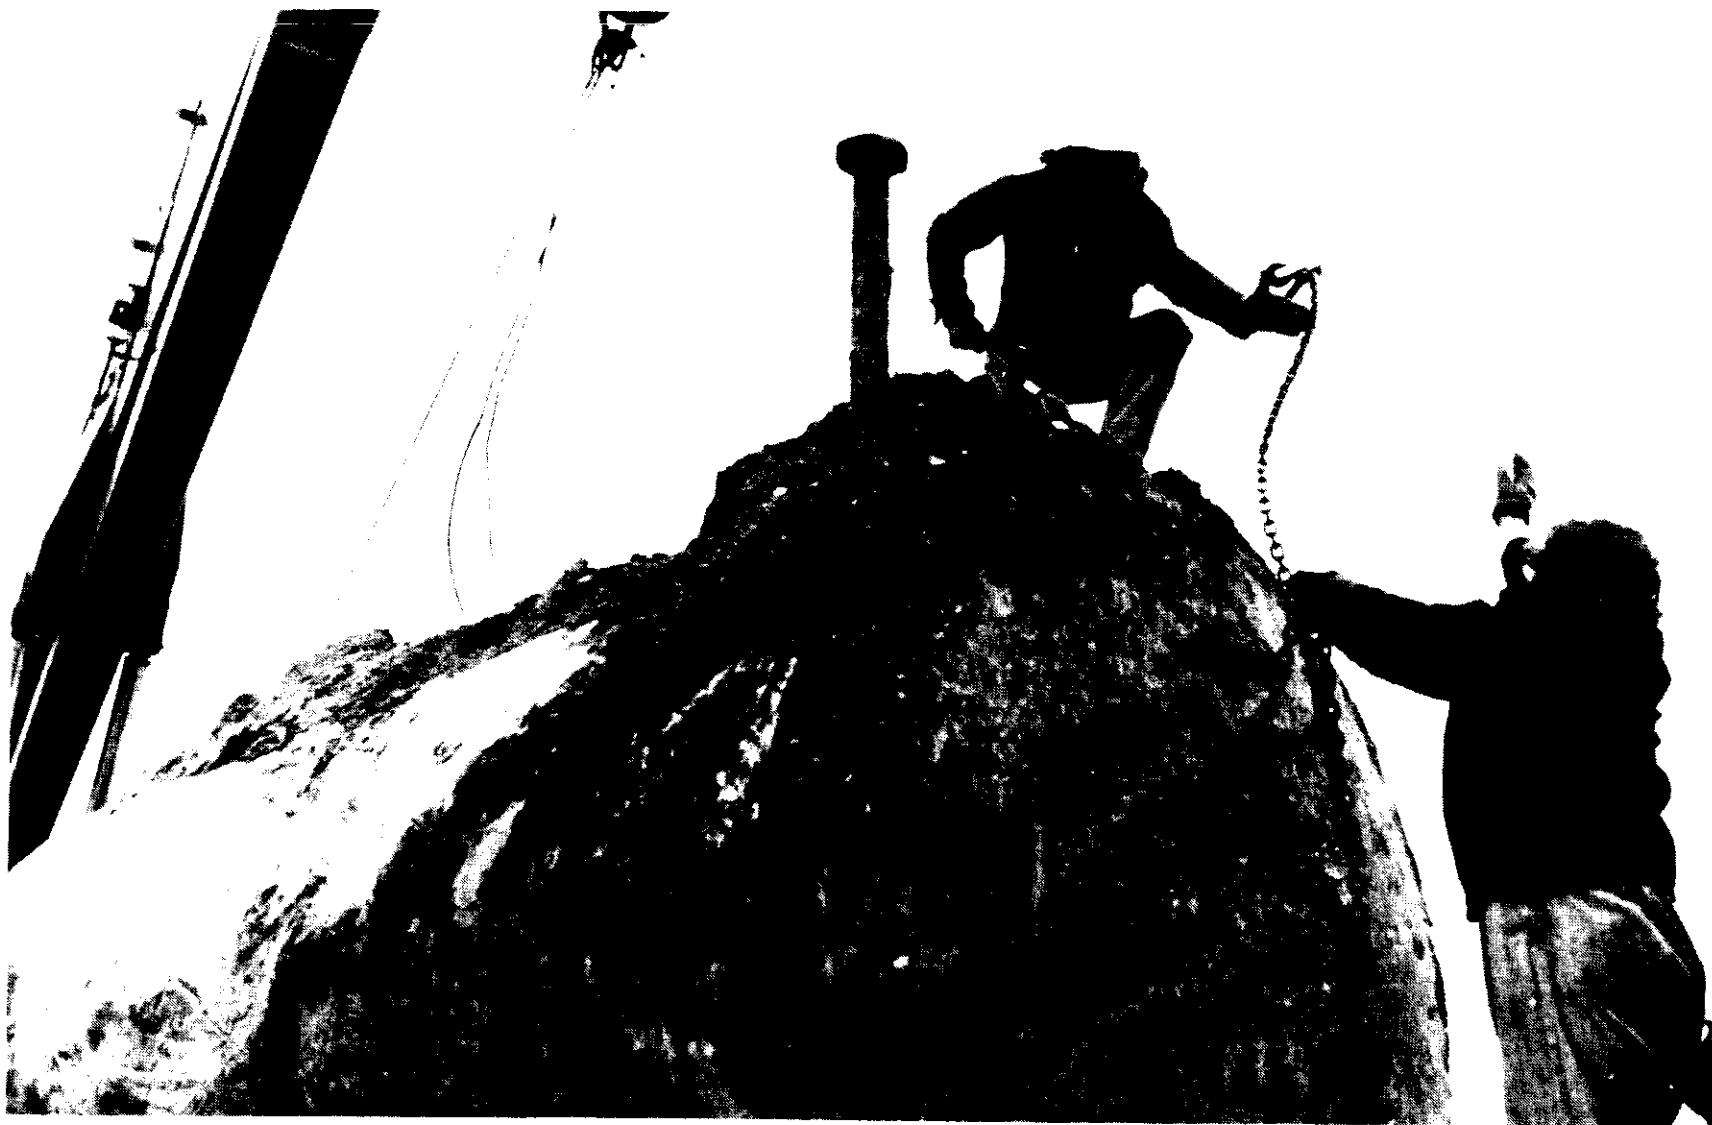
Figure 46. Rigging to xylene storage tank.

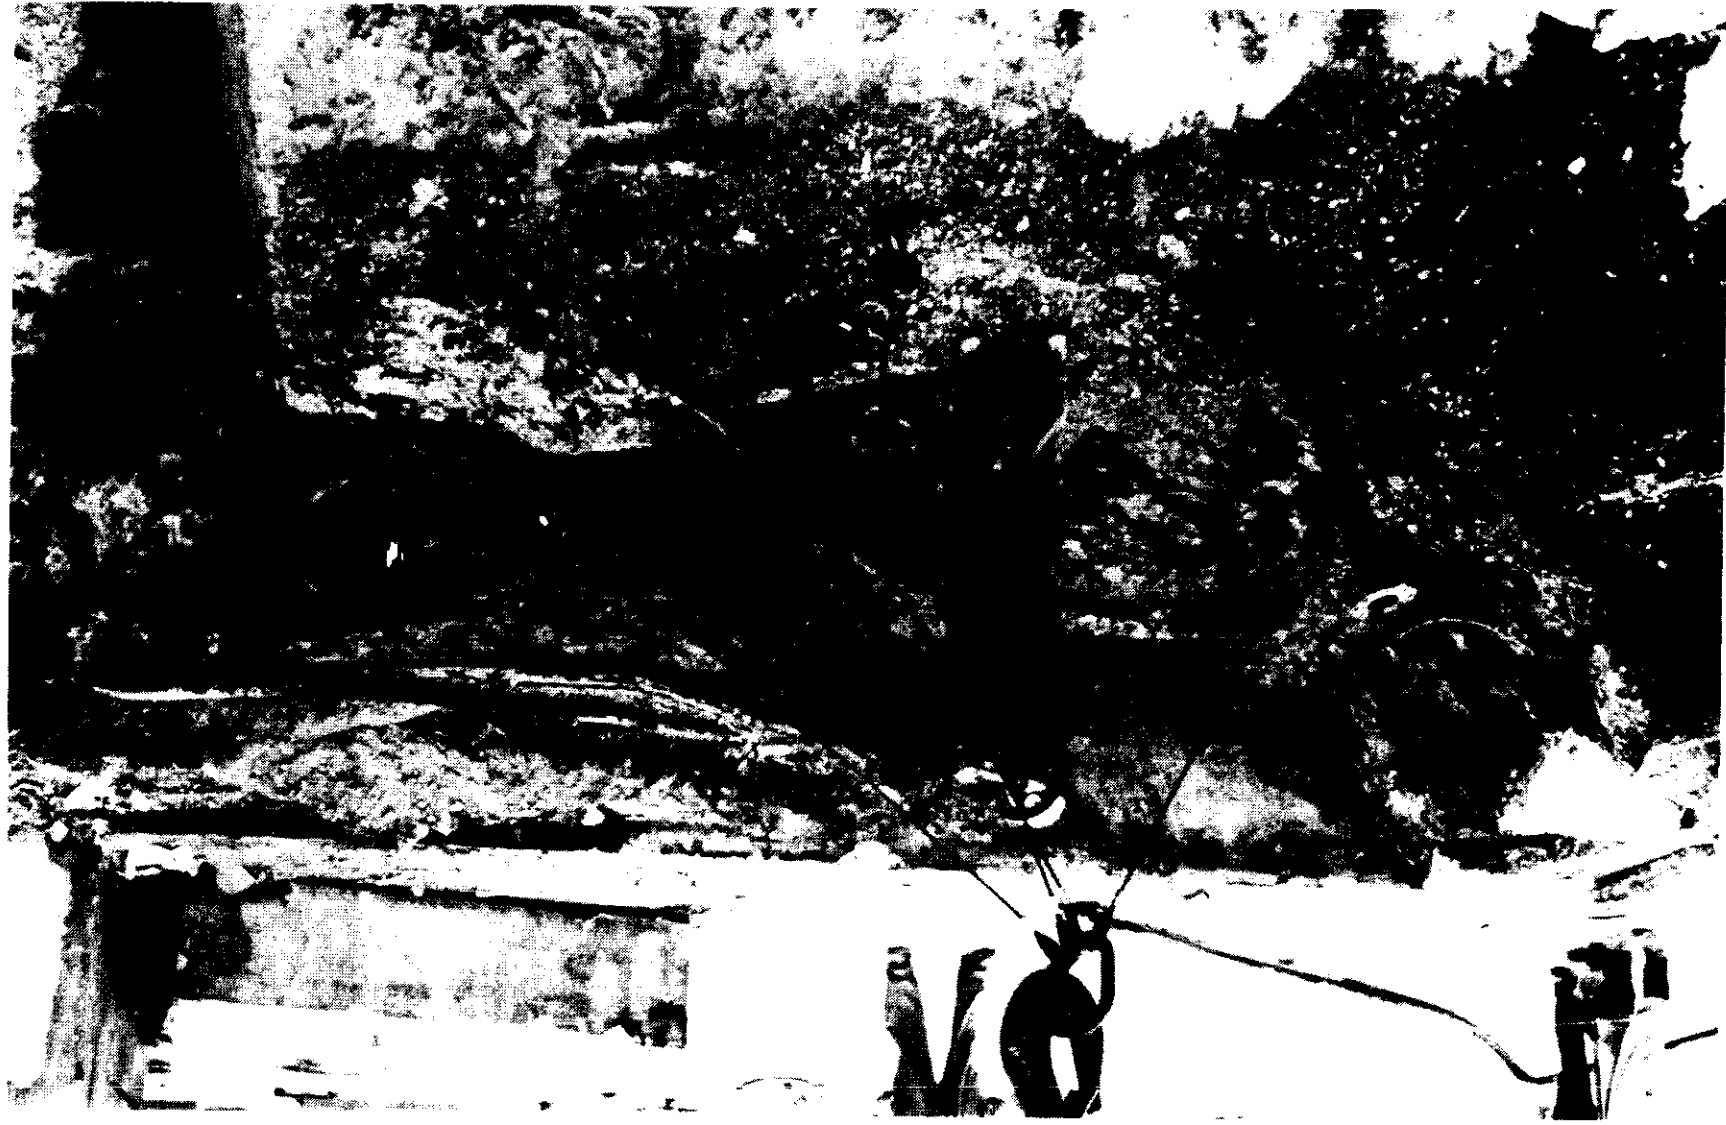
Figure 48. Rigging to the liquid waste tank.

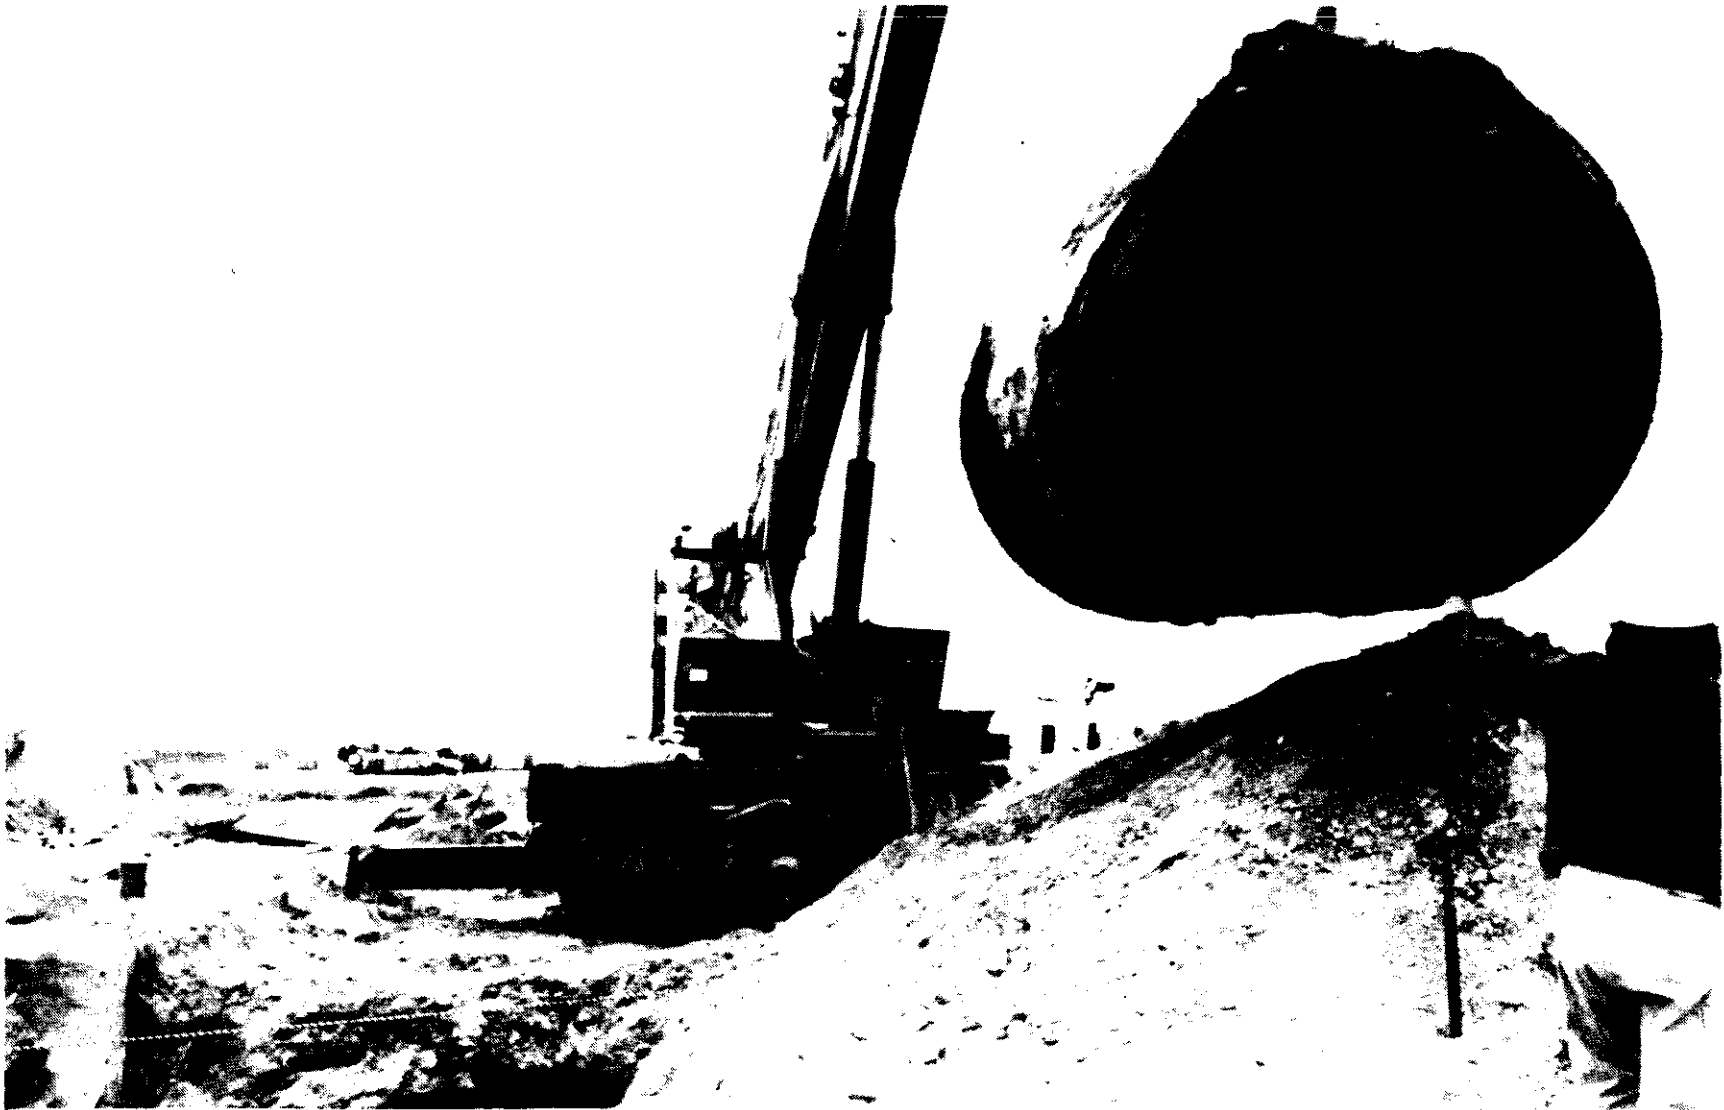
Figure 50. Removing liquid waste tank.

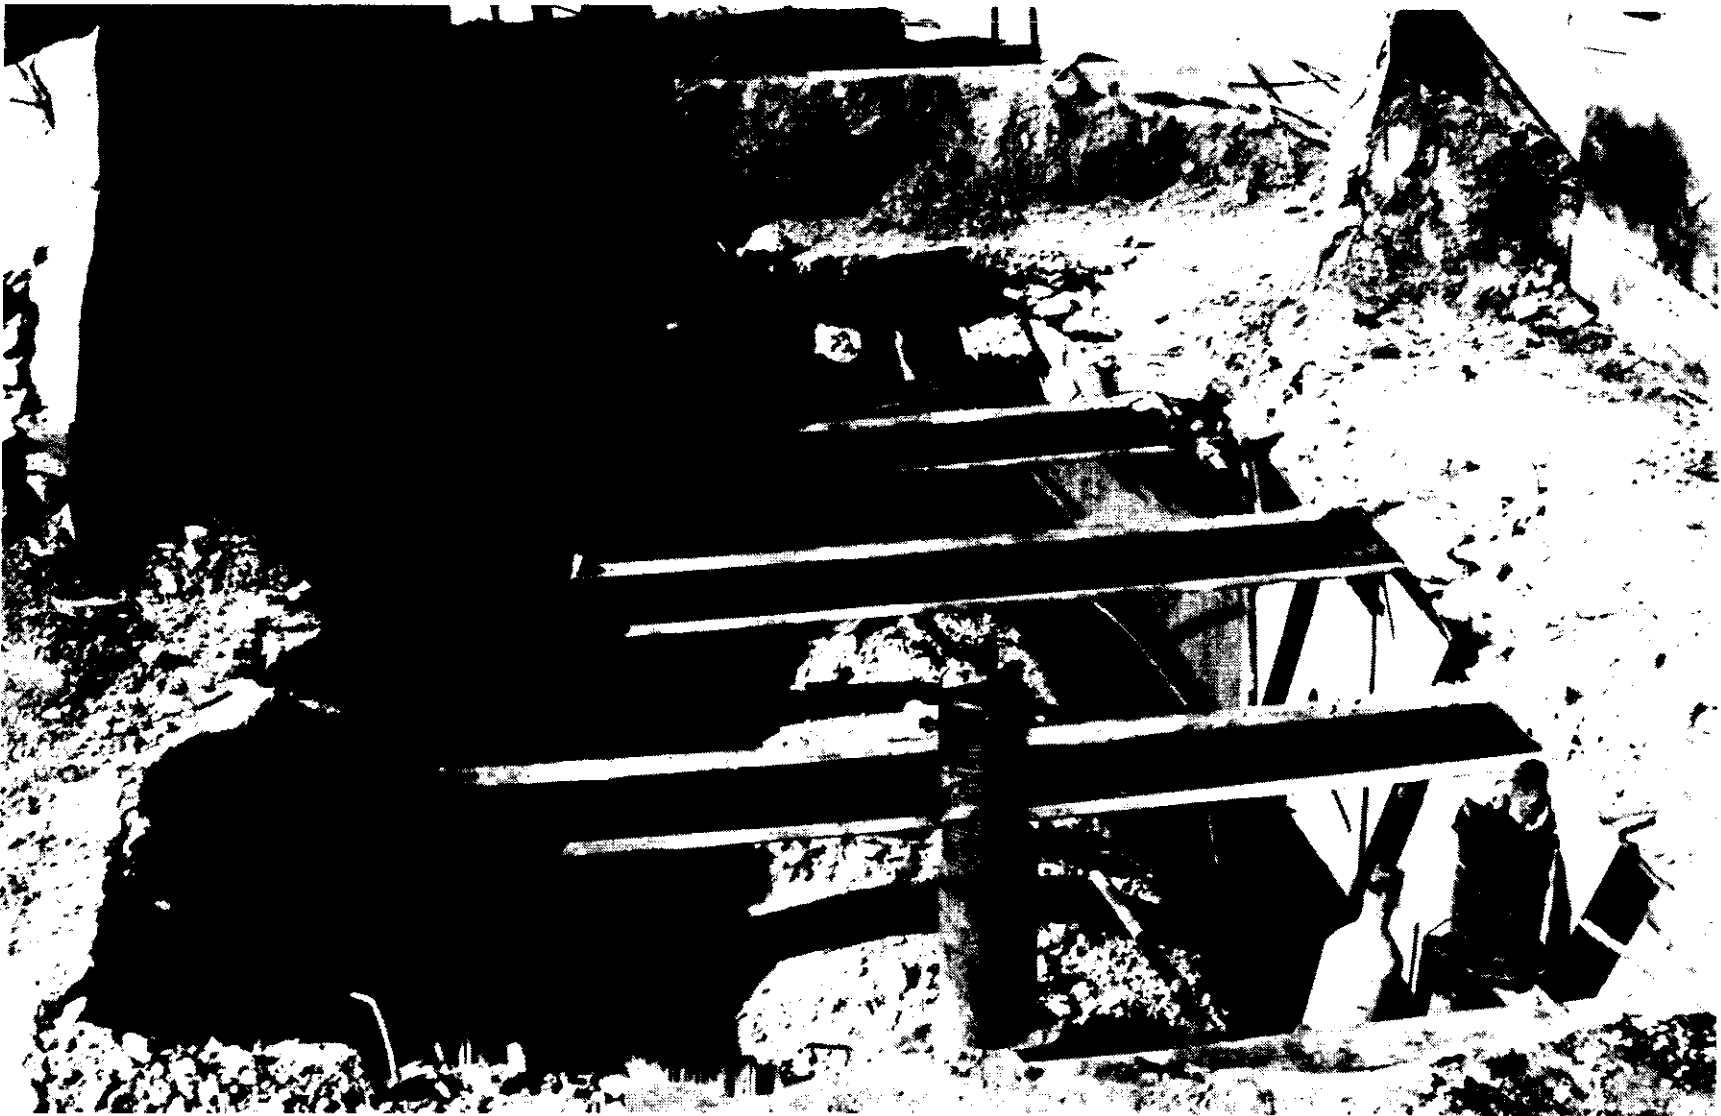
Figure 52. Reactor drain tank vault. I-beams were cut and the drain tank hoisted from vault.

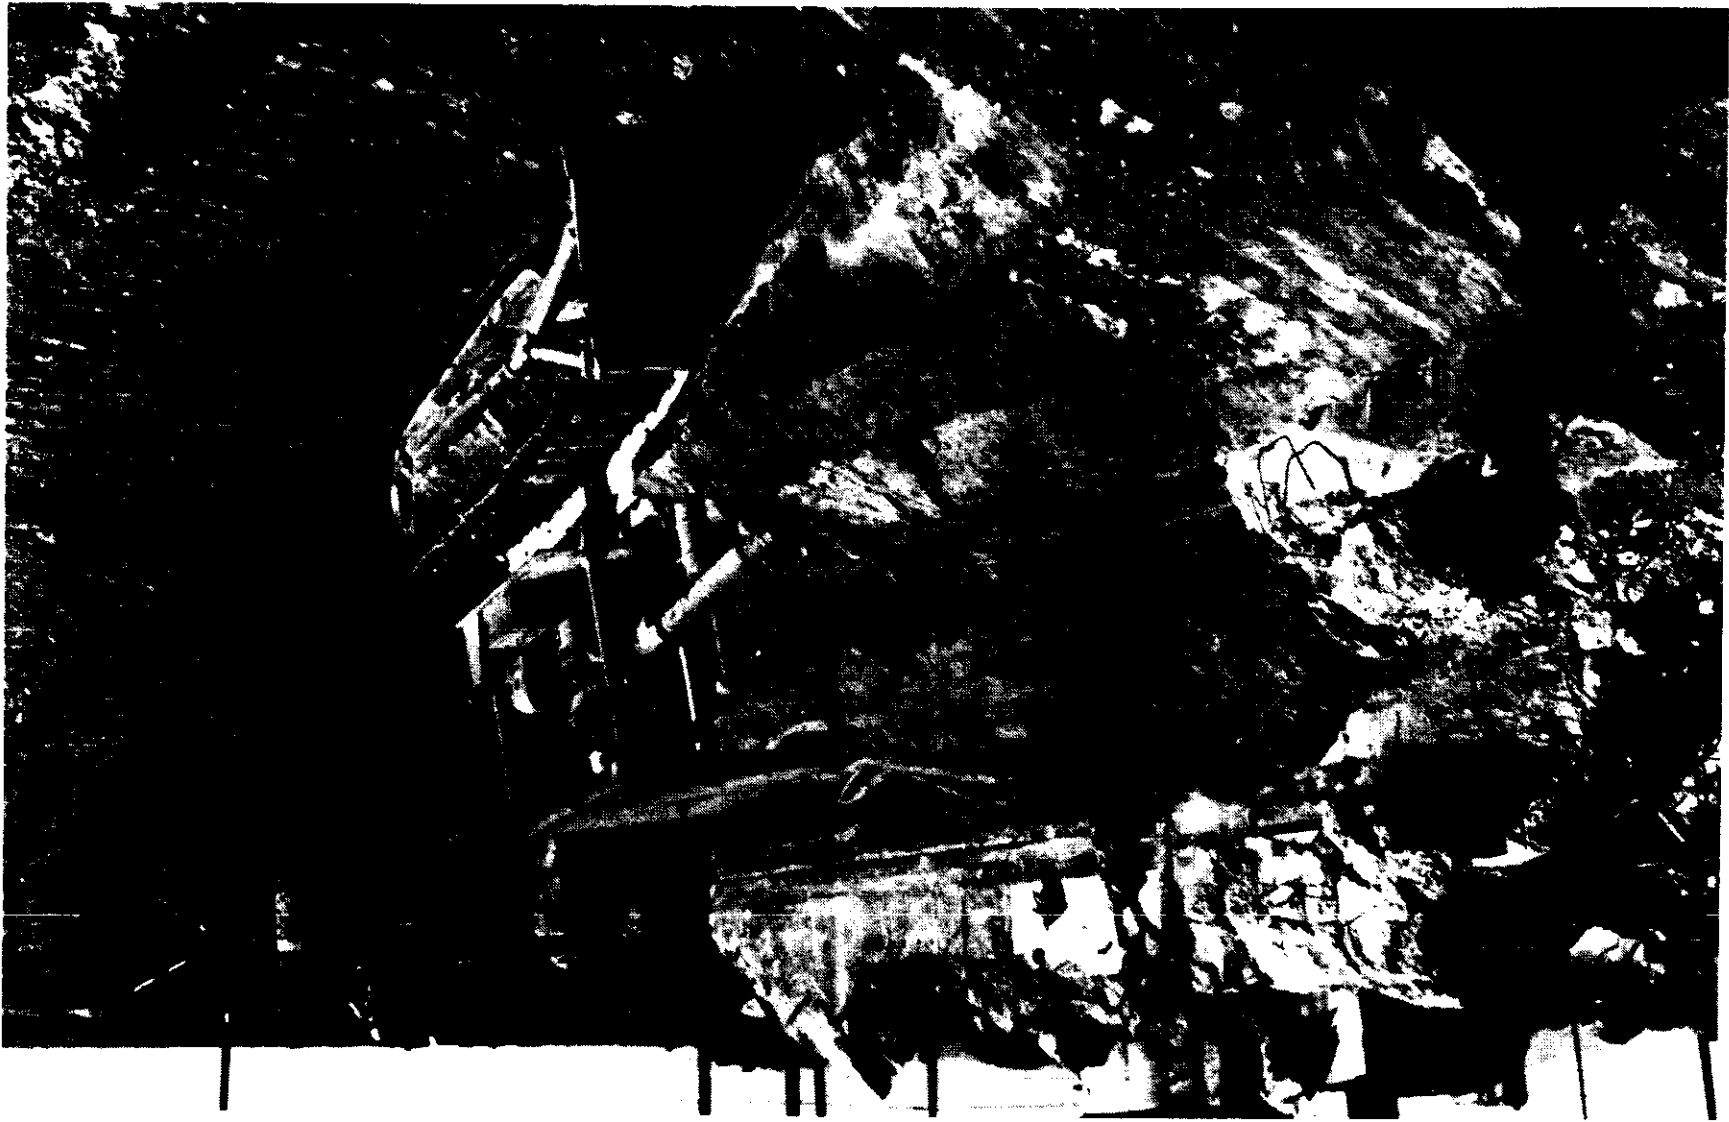
Figure 55. Concrete demolition in progress.

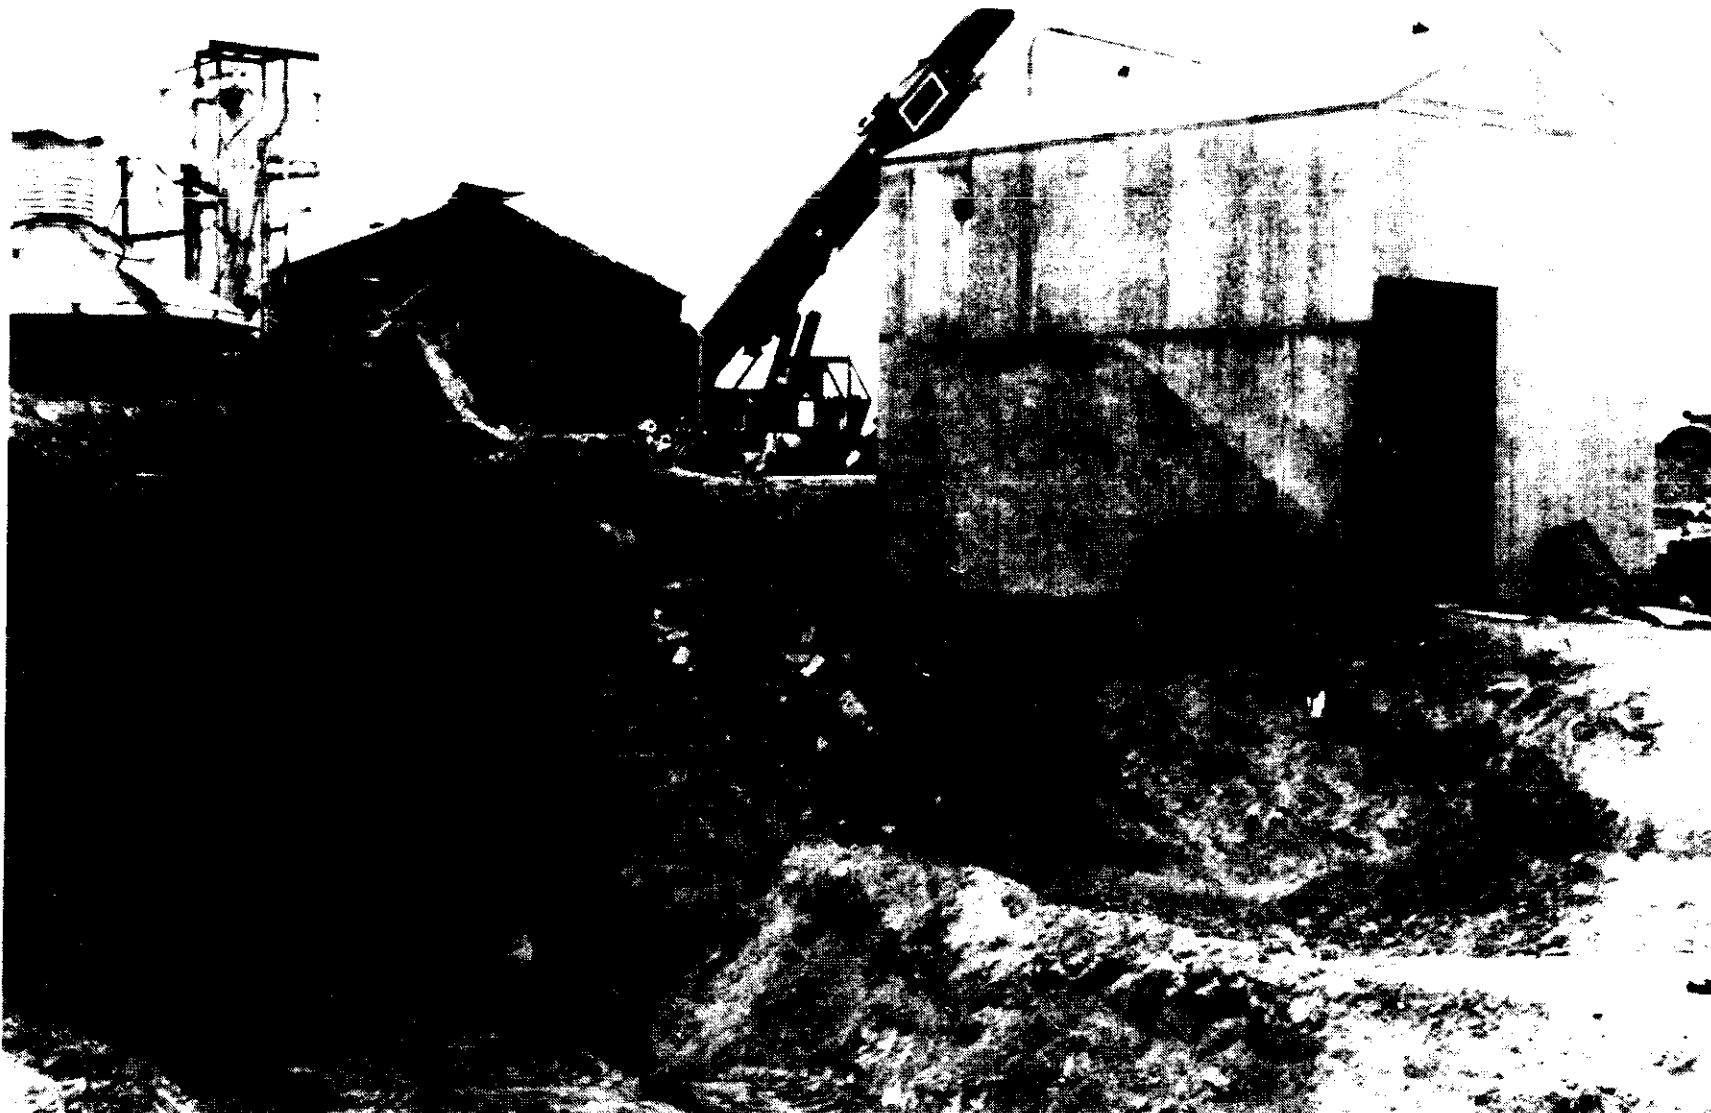
Figure 59. Exposed pipe gallery silo concrete cover slab removed.

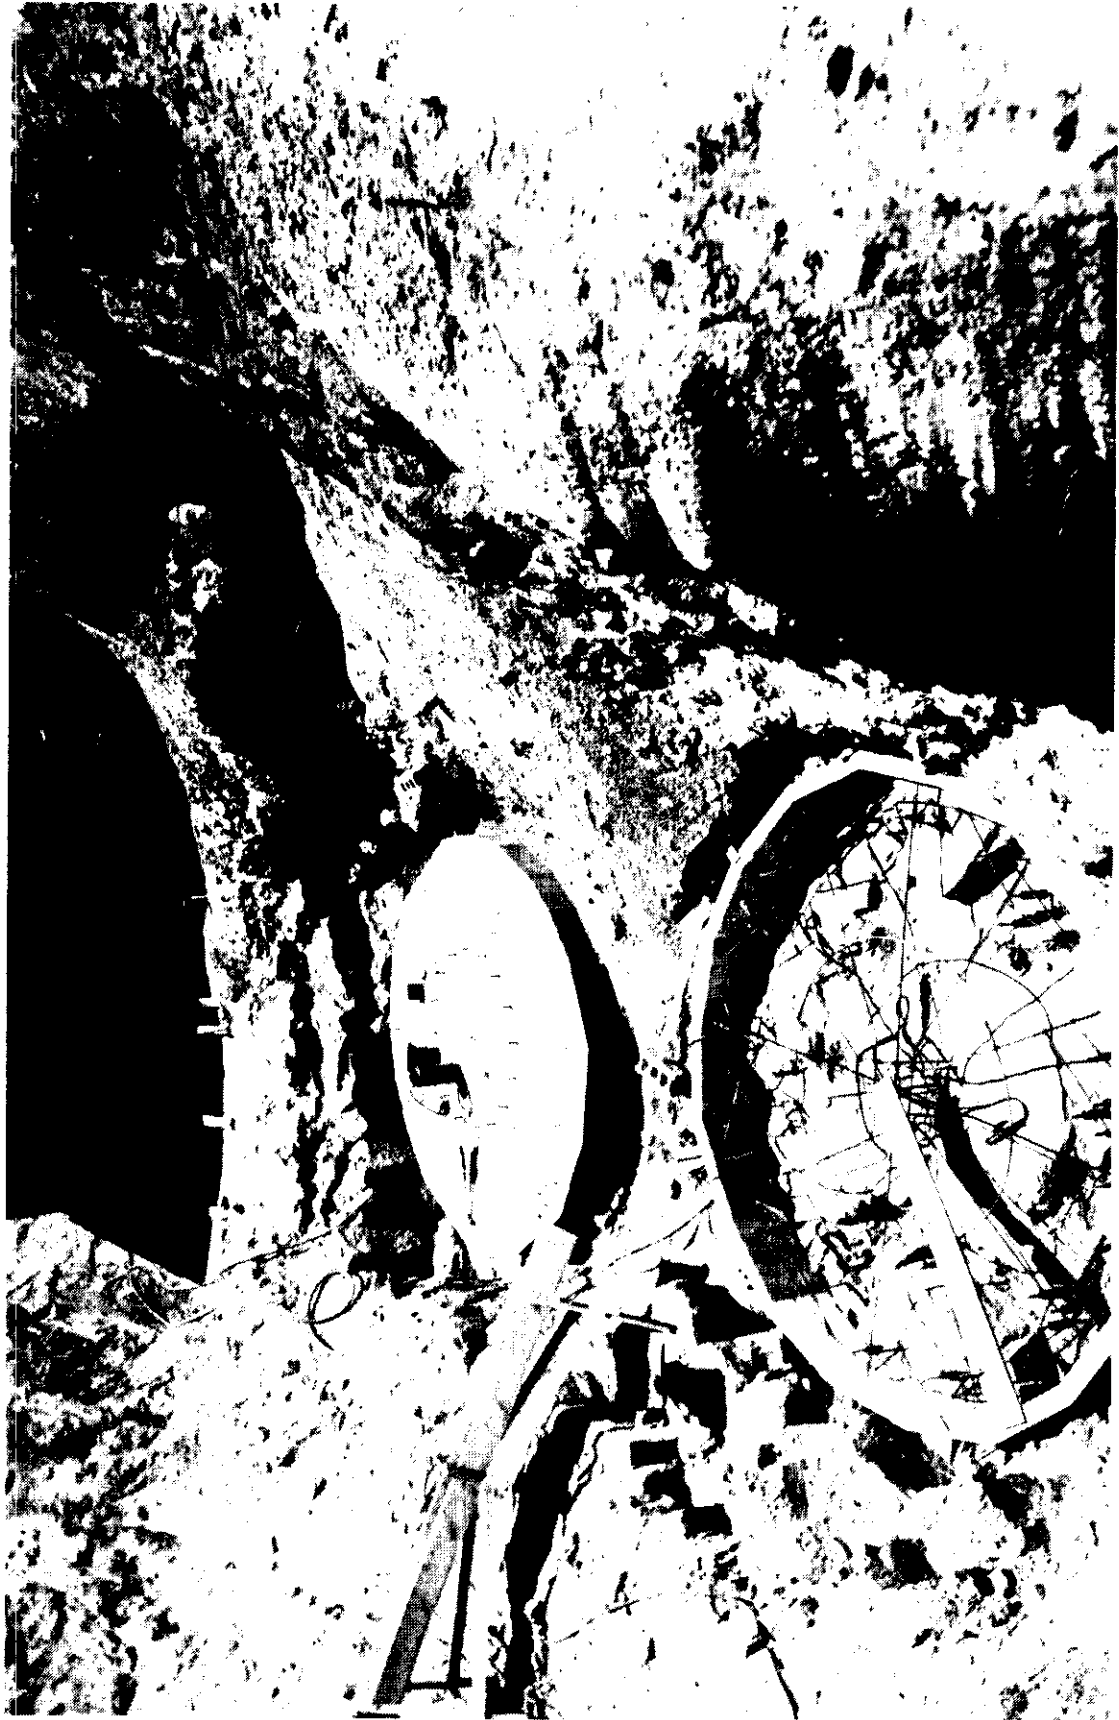
**Reactor Pad.** The reactor pressure vessel was mounted on a concrete slab foundation referred to as the reactor pad. This pad was a reinforced concrete structure poured directly onto a bed of basaltic lava rock. Construction drawings of this pad did not exist; Figure 62, a photograph taken during construction, was the only information available concerning the structure of this pad. After the reactor pressure vessel and its silo were removed, the excavated pit was surveyed to determine the extent of residual radiation on the reactor pad. Figure 63 is a radiation map of the pit. The reactor pad surface field varied from 15 to 50 mR/hr. The results of nuclide analyses of concrete and metal samples taken from the reactor pad surface, are shown in Table 1. These nuclide levels would not permit unrestricted release if left in place. Several techniques for removing the pad were studied, and the use of high explosives was found to be the most cost effective. This provided a unique opportunity to test the control of contamination spread while using high explosives. Several small test blasts were made to evaluate the concrete break characteristics and the throw control.

Figure 62. Reactor and pipe gallery foundations during construction – July, 1956. Reactor foundation in back.

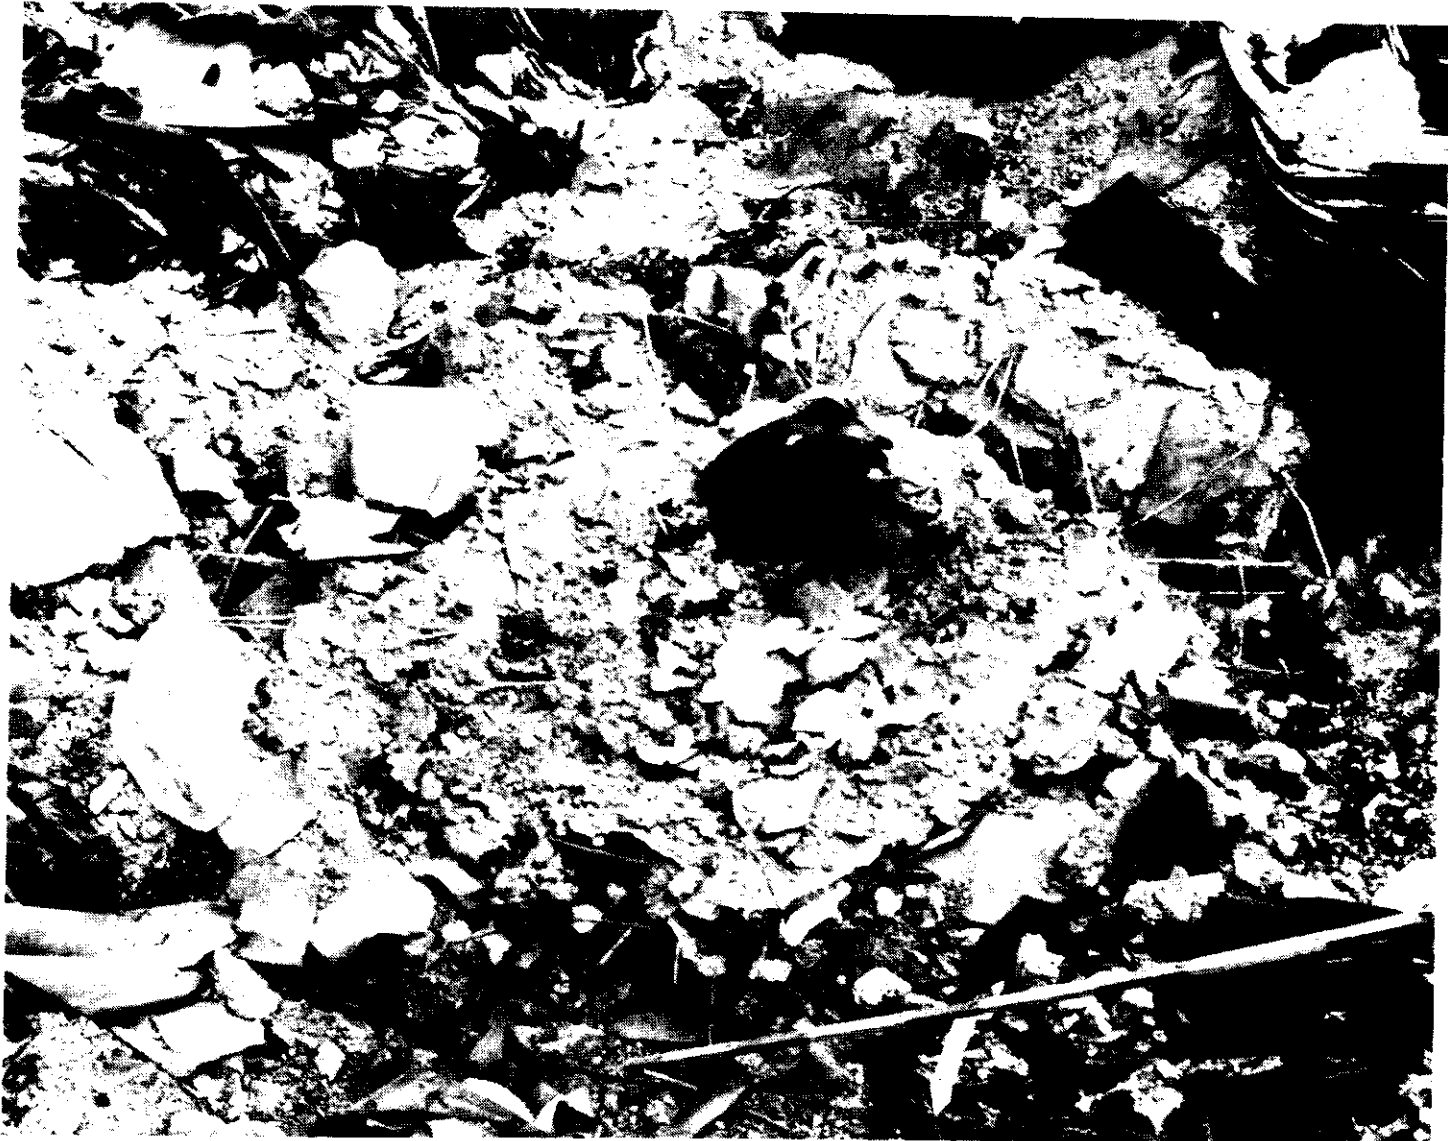
To measure the effectiveness of the contamination control, the entire excavation was covered with hypalon plastic sheet (see Figure 64), several high volume air samplers were placed around the excavation, and one was hung over the pad. Plastic surface wipes were taken and analyzed before and after the blasting. The swipes and the air samplers detected no contamination spread outside the excavation. There was some rock throw, but it was successfully contained within the excavation. Figure 65 shows the concrete pad break up, and Figure 66 shows that the pad was successfully sheared from the basalt bed.

Figure 65. Reactor pad after blasting.

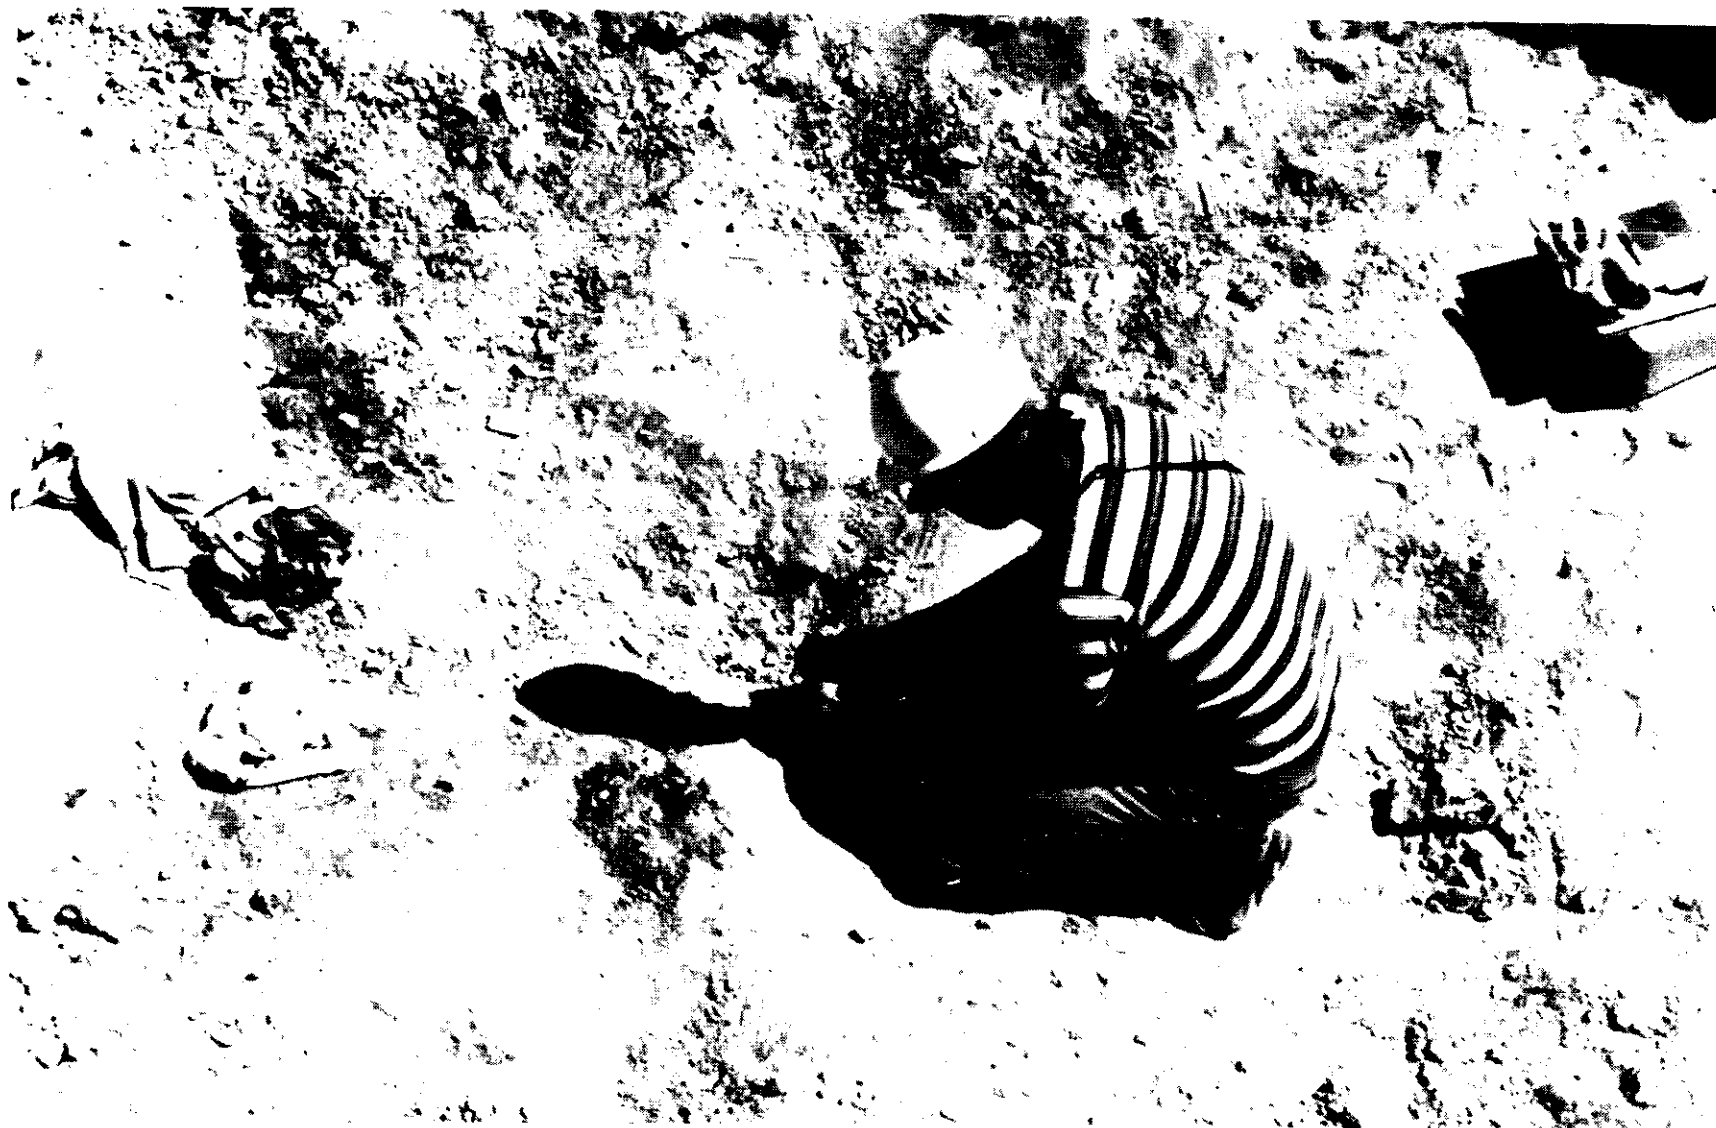
Figure 67. Setting charges in excavation basalt.

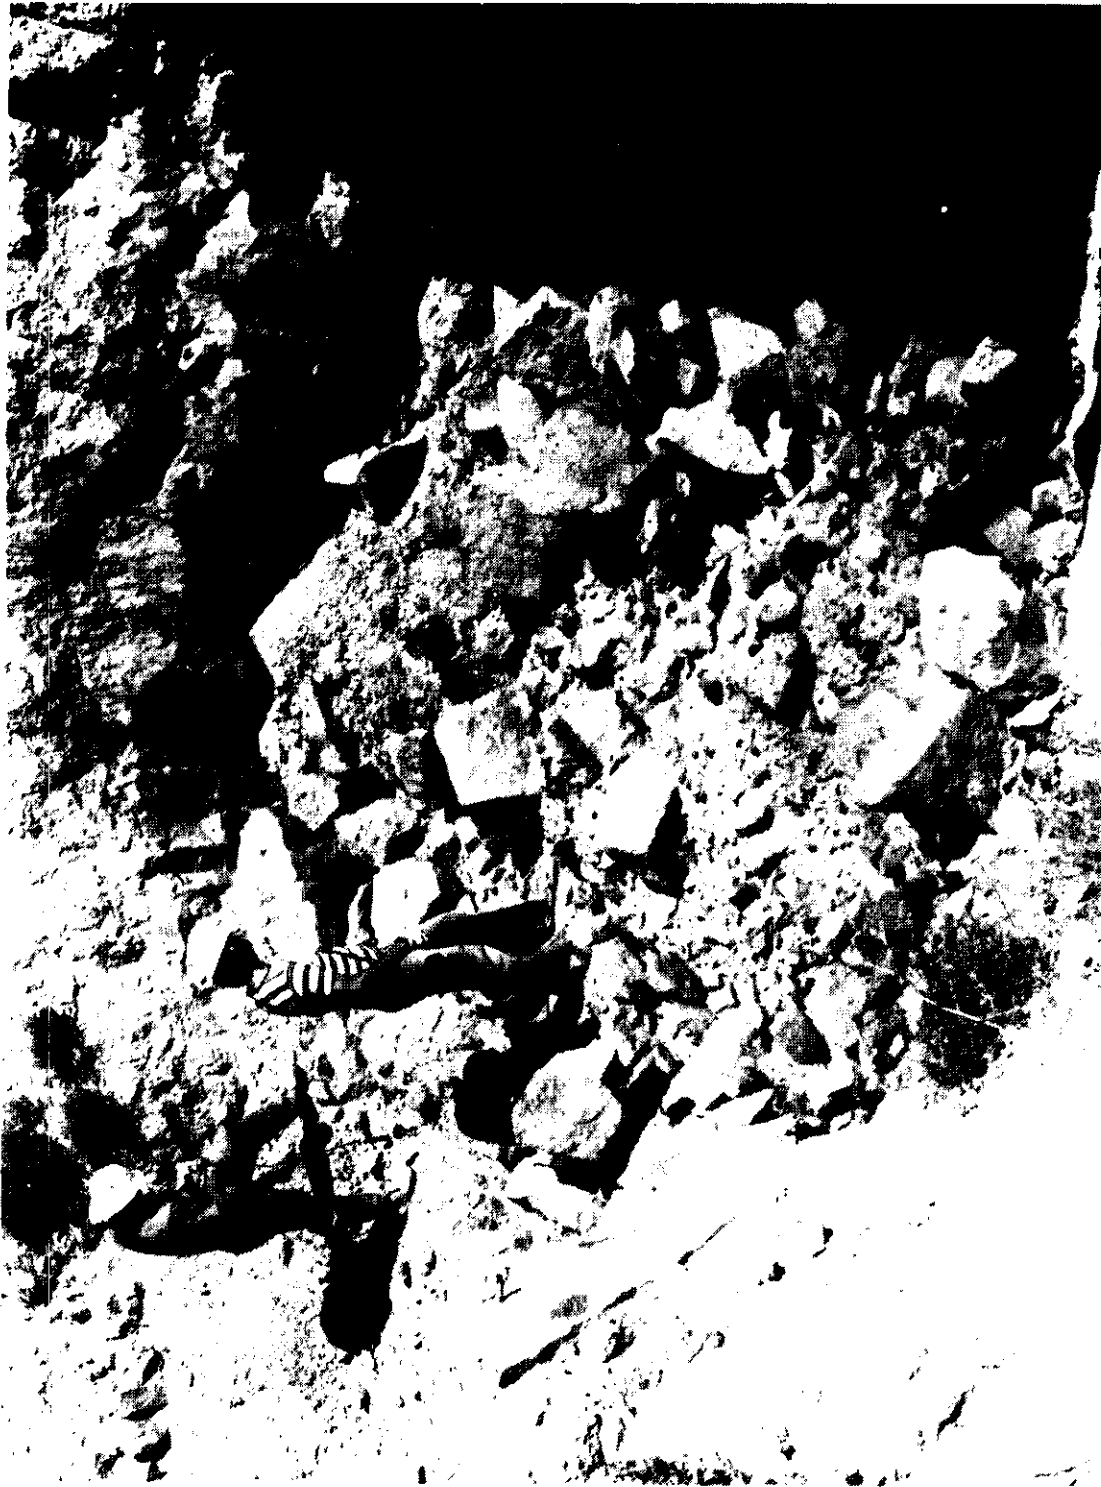
Figure 68. Basalt rubble after blasting.
